## **CONSERVATION DELEMMAS – THE FATE OF THE TIMBER ORTHODOX CHURCH IN MIĘKISZ STARY**

**Jan Kurek**

#### **ABSTRACT**

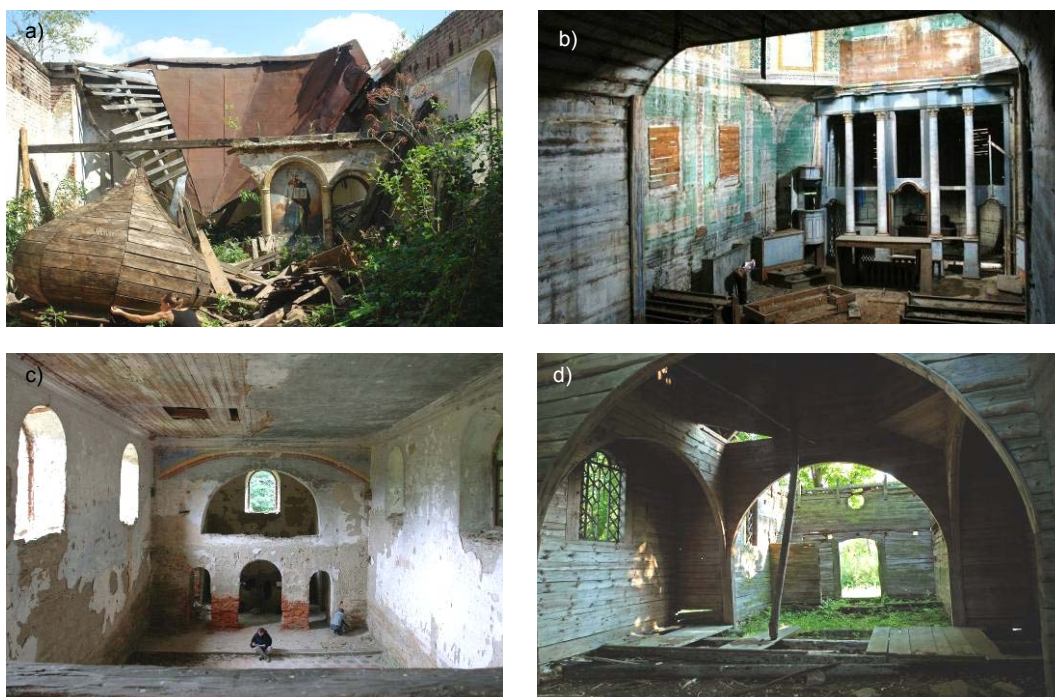
Fig. 1. Examples of Orthodox churches in Poland abandoned and ruined after the Second World War: a) Ujkowice, b) Cewków, c) Królik Wołoski, d) Kotów. Source: photo. author

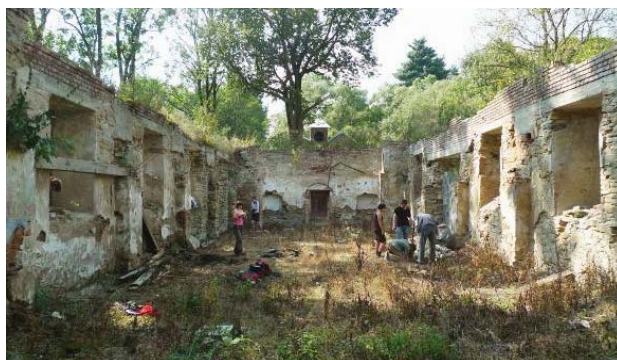
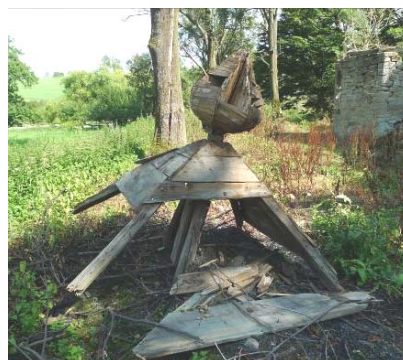
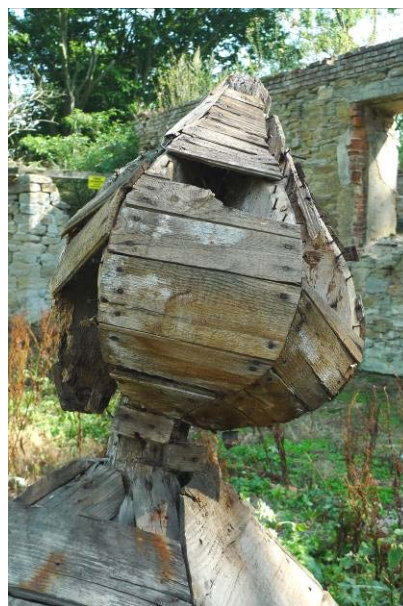
Fig. 2. Płonna, ruins of the church, which was inventoried in 2009 by students of the Cracow University of Technology under the direction of the author. /Photo. author/

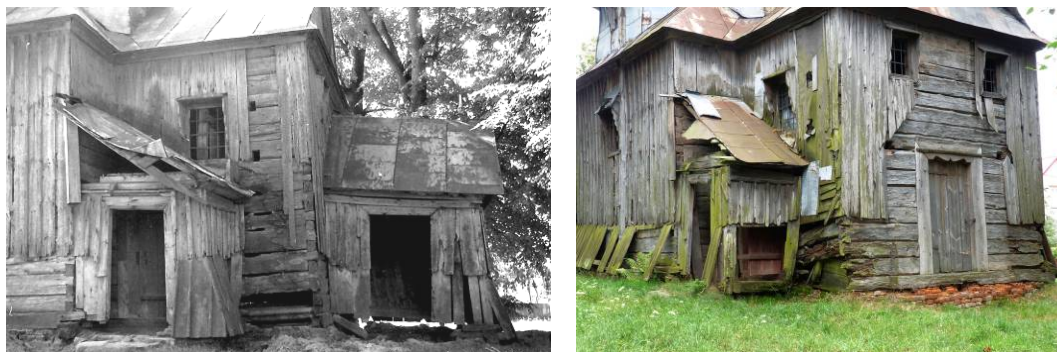
Fig. 5. Mięgisz Stary, progressive degradation of the church's construction structure: state in 1989 (left) and existing state in 2015. Source: photo by author

The Orthodox church in Mięgisz Stary was built probably around 1801, at the site of an earlier Orthodox church, described in an inspection report as an "Orthodox church prone to collapse...". The structure's technical condition was considered poor in 1989 —there were leaks in its steel sheet roof cladding, which was damaged by gunfire during the First World War, and which caused considerable local damage to the timber structure of the ceiling and the walls, the foundations and some of the corners of the walls lost their initial form and stability, some of the boarding of the walls, along with a small roof protecting the bottom part of the walls from rainfall, sustained damage. The polychromes on the walls and dome in the interior were also significantly damaged. The structure's technical condition deteriorated even further in the years that followed.

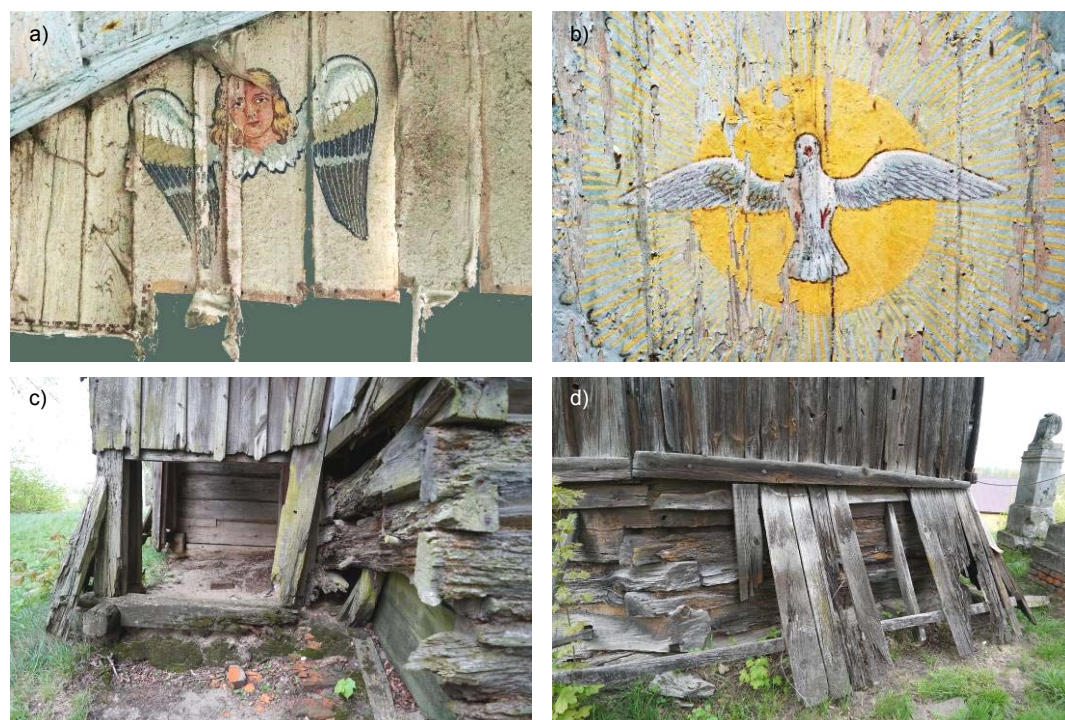
Fig. 8. Miękisz Stary, the condition of the wooden church in 2019: a) a fragment of the presbytery polychrome, b) a fragment of the presbytery polychrome, c) the basement destruction at the north porch, d) the presbytery destruction. Source: photo by author

The comprehensive studies of this historical structure that are proposed in the current design should be indisputably and immediately backed by the Minister of Culture and National Heritage, as well as by the Voivodship Conservator of Historical Monuments<sup>14</sup>. At present, the matter of preparing a structural opinion determining, among other things, the risk of the occurrence of structural failure within the building—with a particular focus on the dome above the nave and the documenting of internal polychromes and securing them—has become highly urgent. It will probably also prove necessary to design and build an additional internal structure that will support the walls and dome above the nave, as well as cover the parts of the building that are currently exposed to rainfall, while simultaneously providing the appropriate necessary ventilation.
